**DEPARTMENT OF TRANSPORTATION**

Contract #: 04-0120F4Cty: SF/ALA Rte: 80 PM: 13.2/13.9File #: 69.28**WELDING INSPECTION REPORT****Resident Engineer:**Pursell, Gary**Address:** 333 Burma Road**City:** Oakland, CA 94607**Report No:** WIR-016399**Date Inspected:** 13-Aug-2010**Project Name:** SAS Superstructure**OSM Arrival Time:** 700**Prime Contractor:** American Bridge/Fluor Enterprises, a JV**OSM Departure Time:** 1900**Contractor:** Zhenhua Port Machinery Company, Ltd (ZPMC), Changxing Island **Location:** Shanghai, China**CWI Name:** Le Zhi Jiang**CWI Present:** Yes No**Inspected CWI report:** Yes No N/A**Rod Oven in Use:** Yes No N/A**Electrode to specification:** Yes No N/A**Weld Procedures Followed:** Yes No N/A**Qualified Welders:** Yes No N/A**Verified Joint Fit-up:** Yes No N/A**Approved Drawings:** Yes No N/A**Approved WPS:** Yes No N/A**Delayed / Cancelled:** Yes No N/A**Bridge No:** 34-0006**Component:** Orthotropic Box Girder (OBG)**Summary of Items Observed:**

## WELDING INSPECTION REPORT

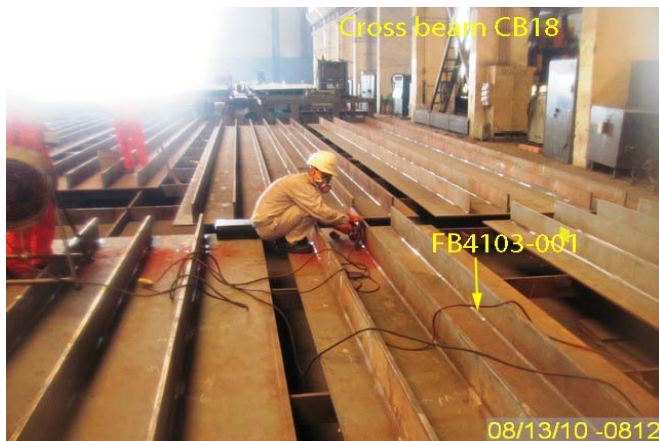
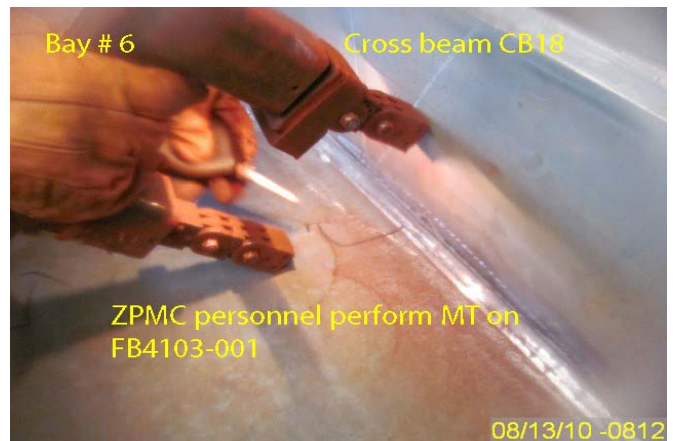
This QA observed ZPMC Magnetic particle Testing (MT) technician perform MT of Intermediate Web Panel on various weld joints. See attached pictures.
